A collaborative engineering and archaeology project to investigate decay in historic rammed earth structures: the case of the medieval preceptory in Ambel

Lorenzo Miccoli ^{a*}, Christopher Gerrard ^b, Chiara Perrone ^c, André Gardei ^a, Christof Ziegert ^c

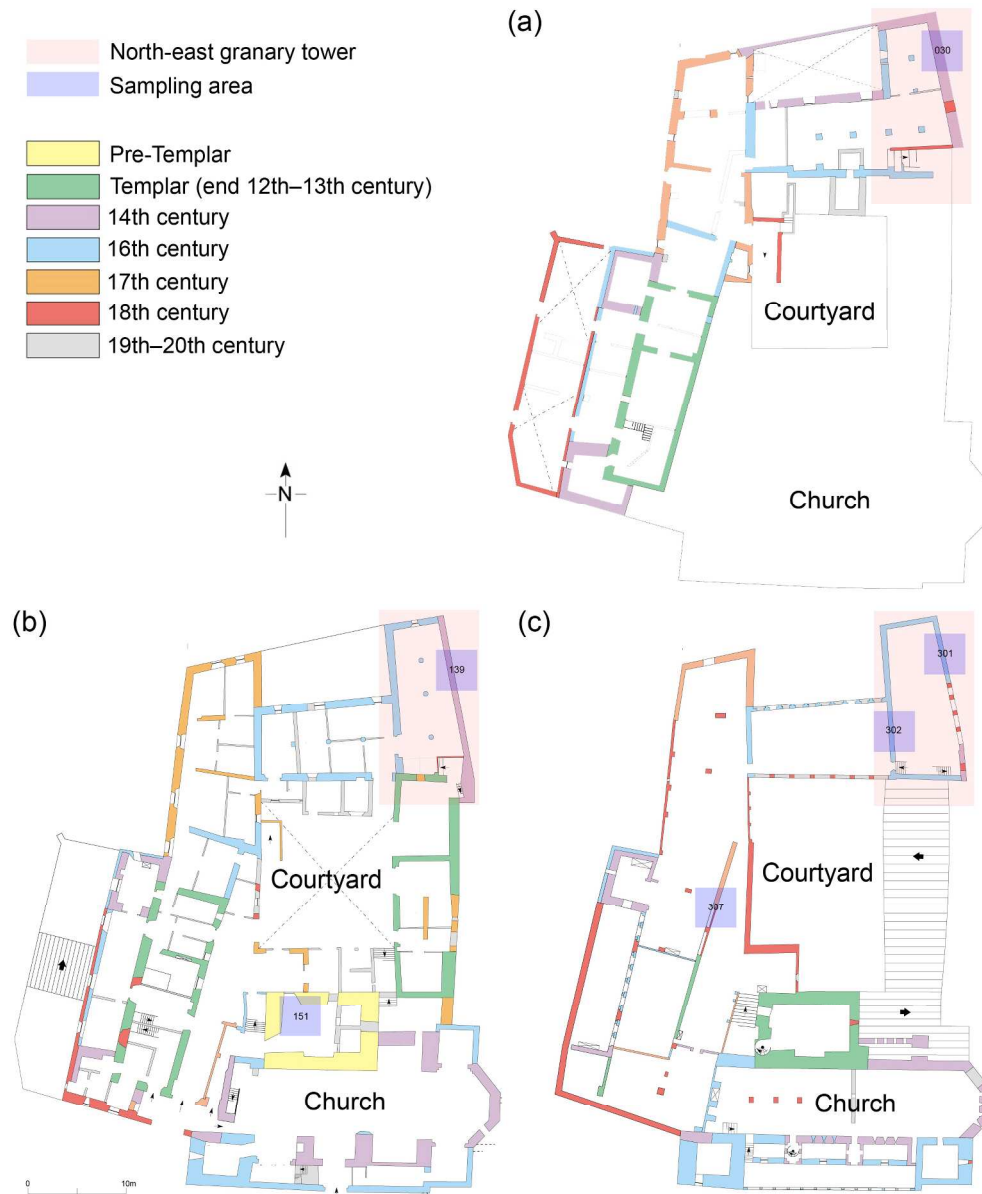
Figure 2. Ambel preceptory. Location of rammed earth samples: (a) ground floor plan with sampling location from R. 030 (14th century); (b) first floor plan with sampling location from R. 139 (14th century) and R. 151 (10th–13th century); (c) third floor plan with sampling location from R. 301 (16th century/1569), R. 302 (16th century/1569) and R. 307 (12th–13th century) (Gerrard 2003).

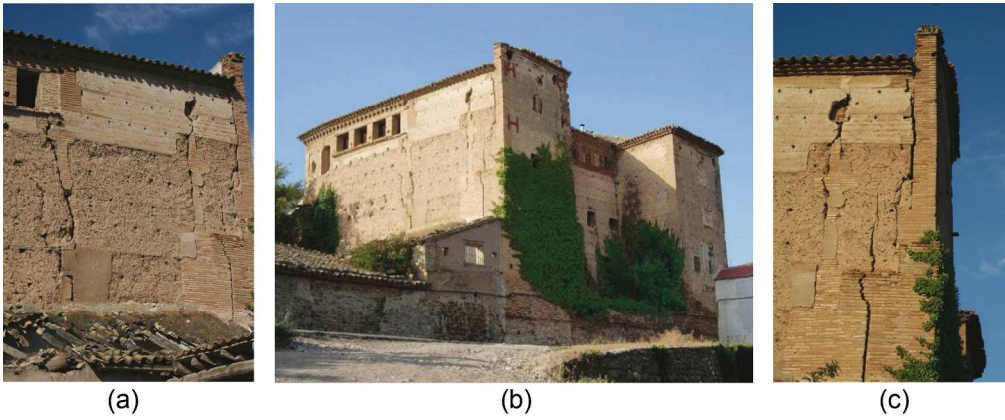
Figure 3. Ambel preceptory: (a), (b), (c) side view of north-eastern granary, looking west.

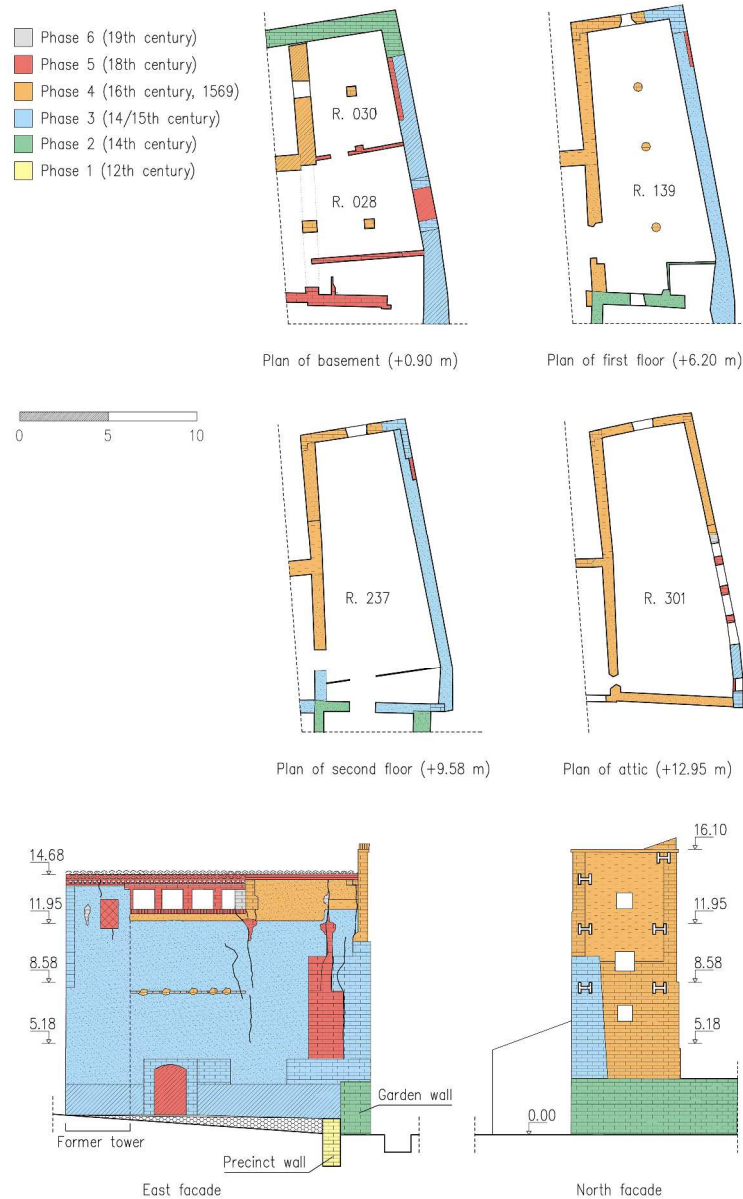
Figure 4. Plans and façades of north-eastern granary tower following the different building phases.

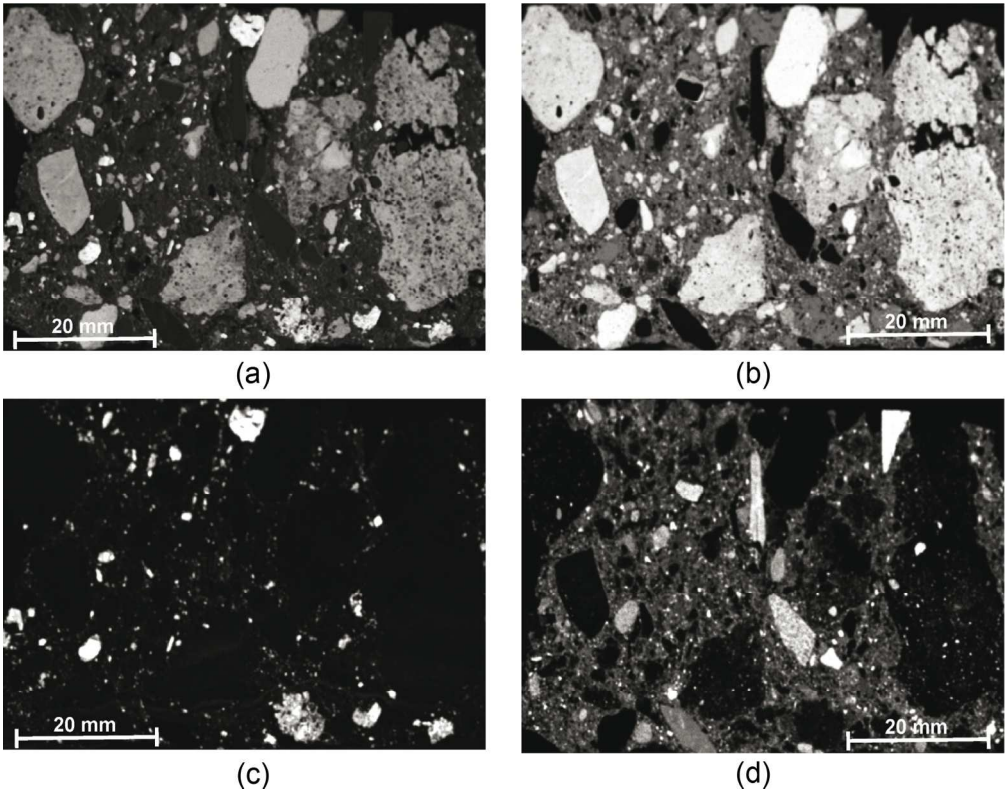
Figure 9. MXRF elemental mapping of sample extracted from R. 307. (a) Structure of the material with calcium, silicon and gypsum. The presence of calcium (b), anhydrite or gypsum grains (c) and silicon (d) registers in white.

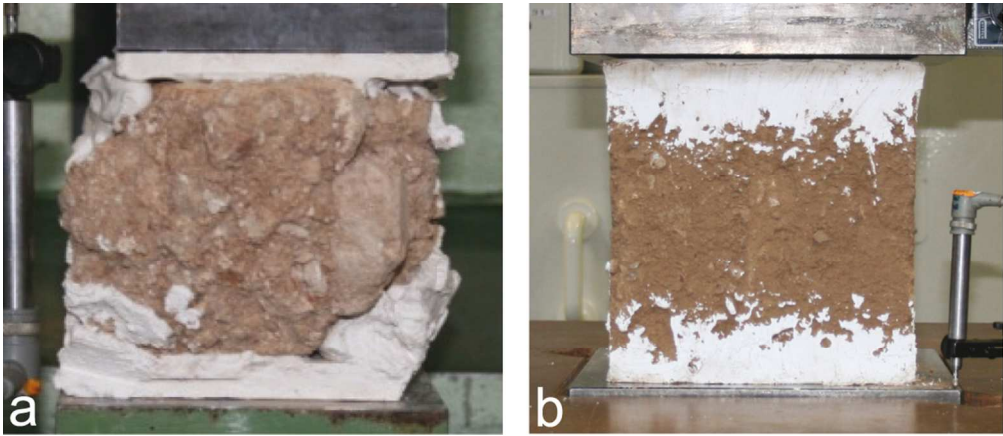
Figure 11. Compressive strength test carried out on sample material from R. 307 (12th–13th century): (a) extracted sample during test, (b) local soil sample.

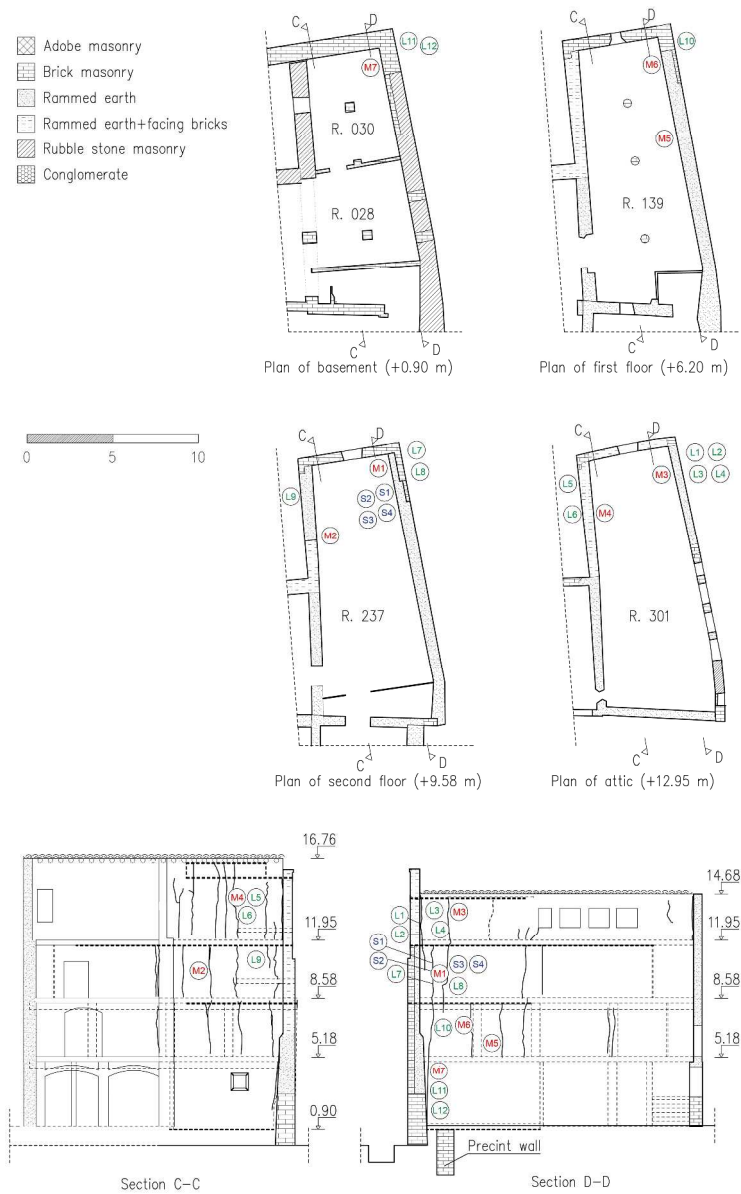
Figure 13. Location of sensors.

33
34 Long-term monitoring, carried out by measuring variations in crack width at twelve different locations (L1–
35
36 L12), had already identified an important displacement in the upper part of the north wall of the tower over
37
38 the past 20 years, with separation cracks being visible today at the junction of the north wall with the east
39
40 and west walls (Figure 3c). At the time the favoured diagnosis of this increase in crack width was the
41
42 rotation of the upper façade on top of the ancient garden wall which at this location functions as a foundation
43
44 (see above). The possibility of differential settlement in the foundation of the north wall was not considered
45
46 likely and, in 2000, steel beams were introduced at all floor levels in order to improve connections with the
47
48 lateral walls.

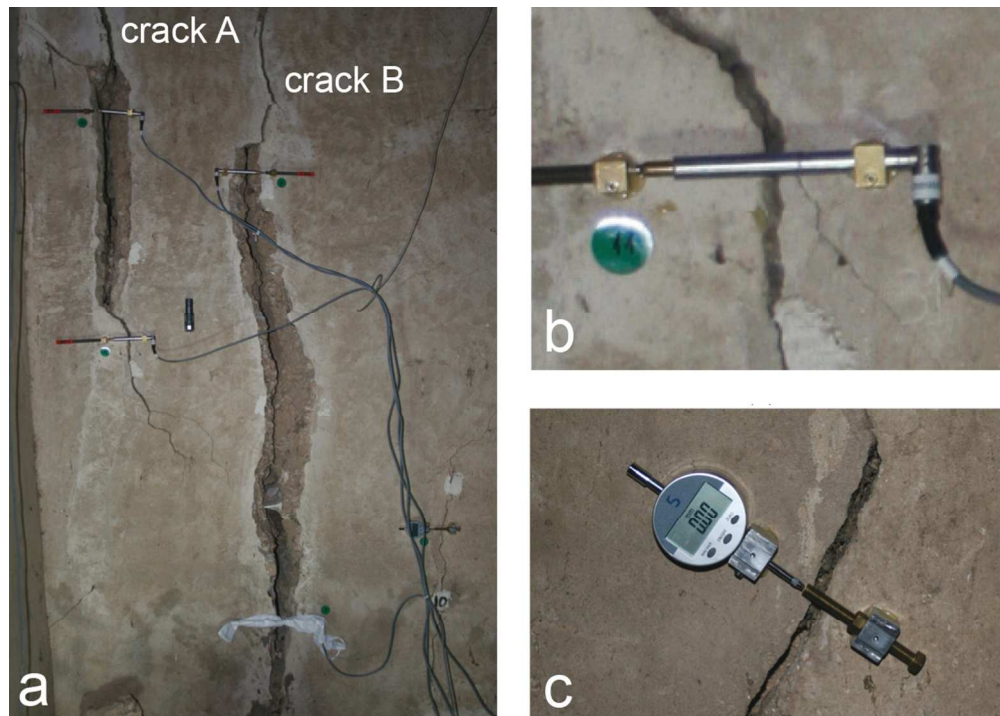
49
50 As part of the present study a more detailed inspection was undertaken around the east wall, here a major
51
52 crack was found to run right through wall. For this reason, four linear differential variable transformers
53
54 (LVDTs), indicated as S1–S4 shown in Figure 14a,b, were installed on the interior of the façade for a short-
55
56 term monitoring. Other visible cracks on the east and west walls were monitored through medium-term
57
58
59
60

monitoring (M1–M7) using seven digital crack meters (Figure 14c). The thermo-hygrometer was placed close by near the central courtyard. Details on the location of sensors are provided in Table 3.

Figure 14. LVDTs used in short-term monitoring (a,b); digital crack meters used medium-term monitoring (c).
